# Manhole Inspection Summary

Manhole # S37GG1011MH

Insp Date: **1/10/07 3:58 PM**

**Location** Address: **3816 JUNIPER RD**

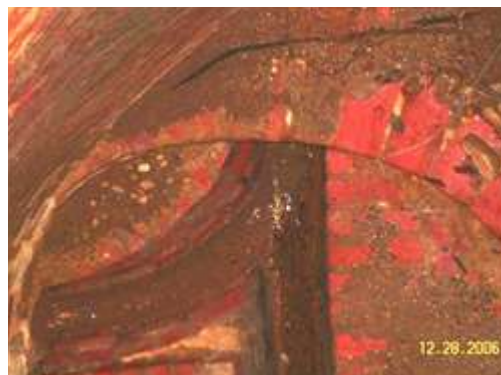
Top View

Evidence of surcharge - Bench debris.

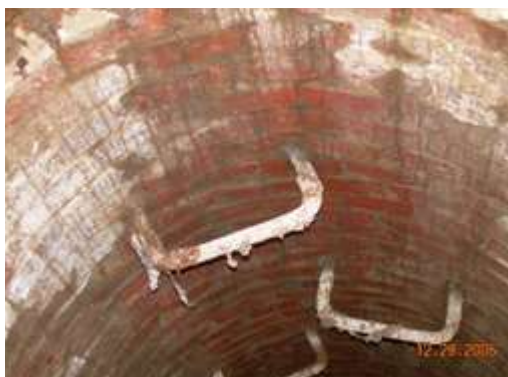
Defect

Condition: ☐ Sound ☐ Cracked ☐ Root Intrusion ☐ Loose Brick ☒ **Deteriorated**

Infiltration: ☐ None ☒ **Joint** ☐ Cracks ☐ Mortar ☐ Roots ☒ **Wall**

Corbel deterioration and infiltration.

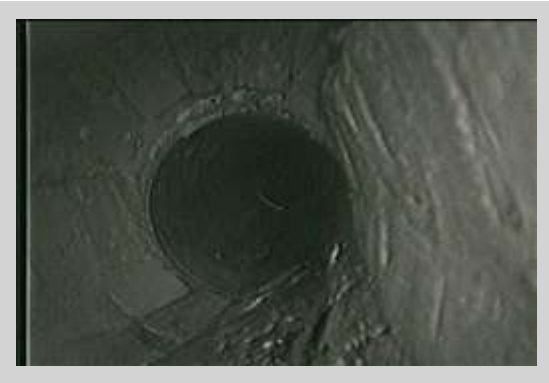
### 8 in. Circular Gravity Sewer Pipe Out @ 12 O'Clock

Pipe Material: **Clay** ☐ Pipe Lined

Invert Depth: **11.61** (ft.) Flow Characteristics: **Slow**

Infiltration: **None** Pipe Seal Cond: **Unknown**

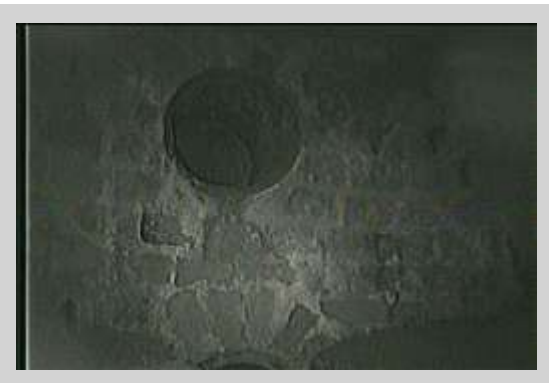
### 8 in. Circular Gravity Sewer Pipe In @ 6 O'Clock

Pipe Material: **Clay** ☐ Pipe Lined

Invert Depth: **9.20** (ft.) Flow Characteristics: **Slow**

Infiltration: **Evidence** Pipe Seal Cond: **Unknown**

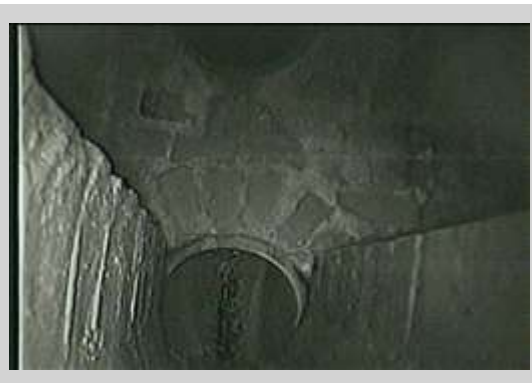
### Drop In @ 6 O'Clock

Drop: **Outside** Rod and Bar

Angled: **Yes** Reading: **10.51** (ft.)

Inv Depth: **11.51** (ft.)

Drop Condition: **Open**

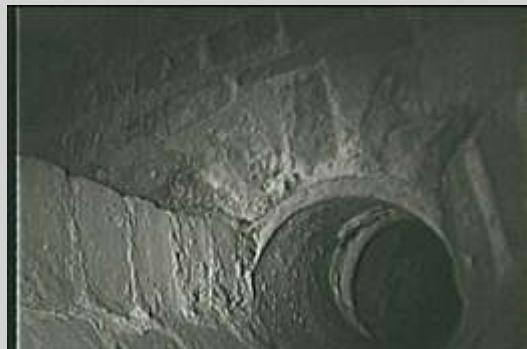
Pipe In @ 9 O'Clock

Pipe Material: **Clay**

Invert Depth: **11.43** (ft.) Flow Characteristics: **Slow**

Infiltration: **None**
